# Corvara

COR-N-SW-NO / COR-N-SM-NO

BV-2.1\_0071

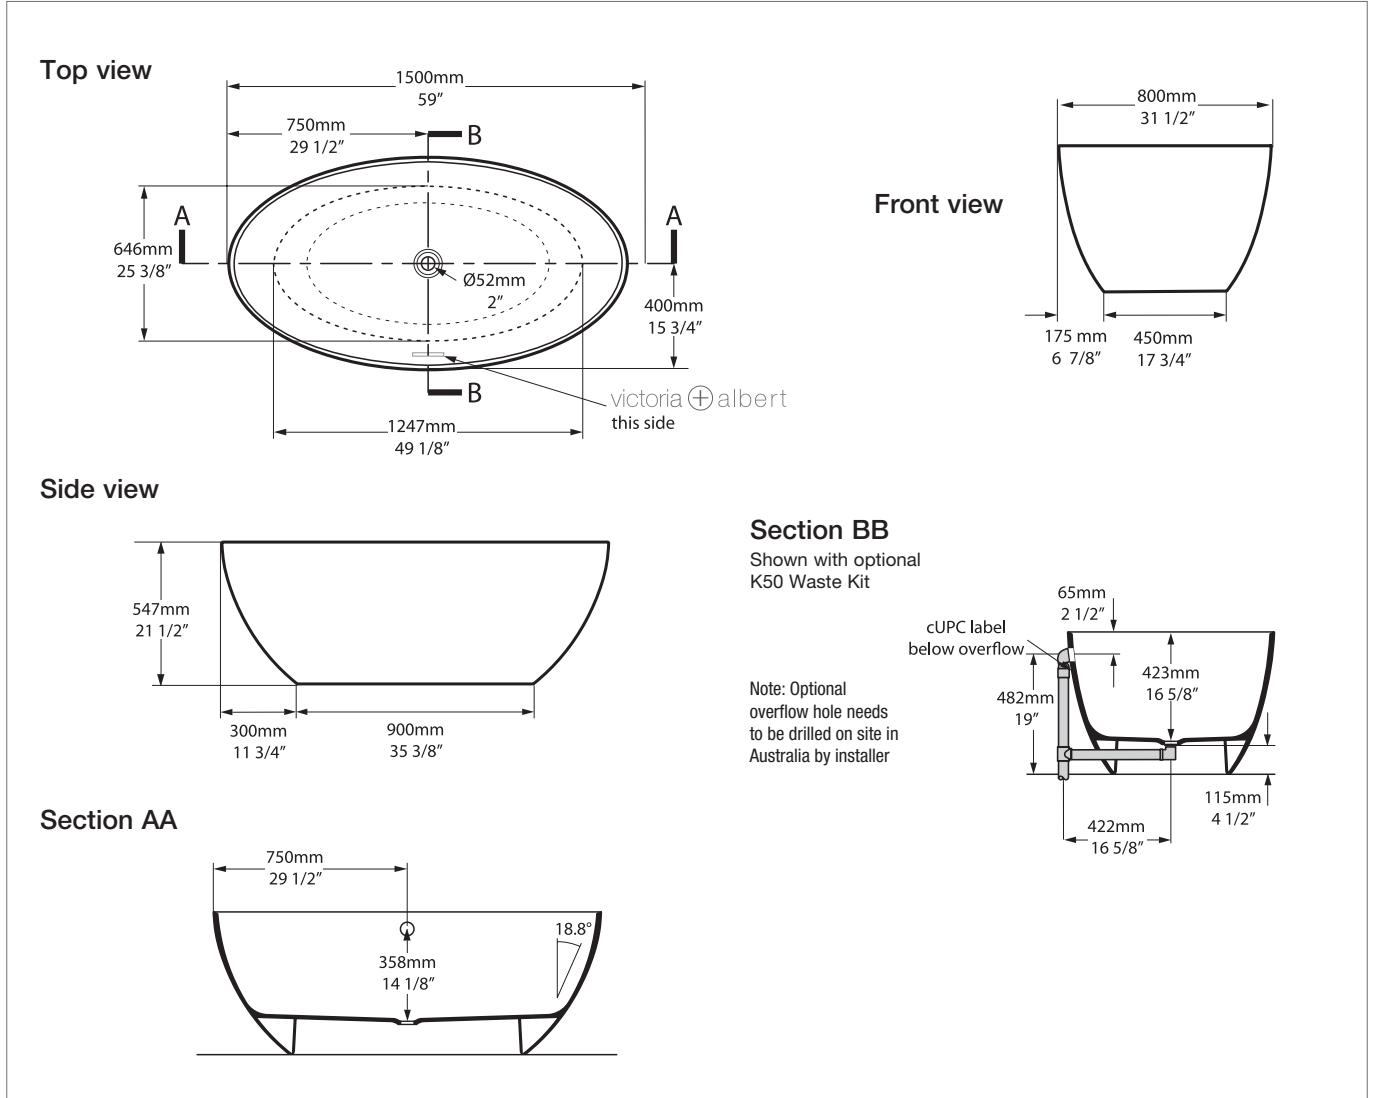
**Note:** All baths in Australia come standard **without** an overflow.  
When installed with optional K50 waste kit, the overflow hole needs to be drilled on site by installer.

369 KG	294 ltr
243 KG	168 ltr
75 KG	0 ltr

**Recommended wastes:** K-12-xx / K-50-xx

\*All measurements subject to +/-5% tolerance  
 \*Overflow hole not drilled
